TECHNICAL REPORT

**“THERMOGRAPHIC ANALISYS AS APPLIED TECHNIQUE
OF PREDICTIVE MAINTENANCE IN THE ELECTRICAL
INSTALLATIONS OF MEDIUM AND LOW VOLTAGE OF THE
PUMPING SYSTEMS SECTOR URBAN EMAPA-I”**

Ibarra – 2015

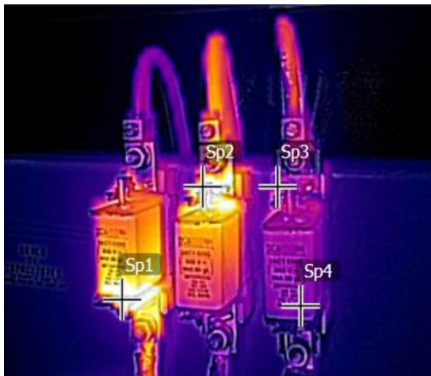
Graphic 2. Qualitative method.

Here the existence of a temperature anomaly is detected.

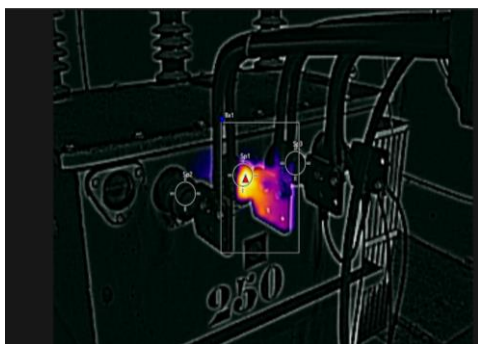
Graphic 4. Thermal setting.

Then a thermal image in which the adjustment was made is indicated, the problem resides in the bushing of phase 2 of the transformer:

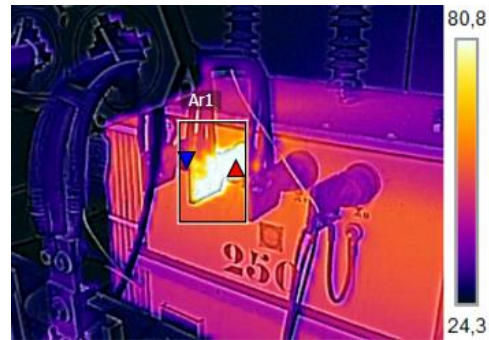
Graphic 5. Measurement área.

The measurement area is identified by the name Ar1.

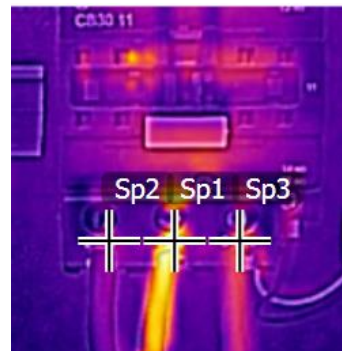
Graphic 6. Measurement points.

Faulty stage here compared to other phases at the same points.

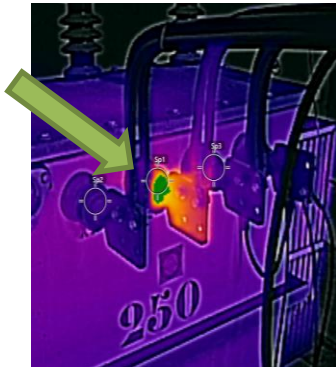
Graphic 7. Isotherm.

Using this technique it was found that the hottest area comes from the inside of the base of the transformer bushing.
